**INTERIOR LEAST TERN POWERLINE COLLISION ON THE LOWER PLATTE RIVER**—Collisions with electrical powerlines are a well-known documented cause of avian mortality (Avian Power Line Interaction Committee [APLIC] 1994, Savereno et al. 1996). Mortality caused by collisions with powerlines can be an important concern for many bird species, but is a serious conservation problem for threatened and endangered species because any mortality can have biological and legal ramifications (Janss 2000). Loss of individuals, particularly breeding adults, from an already small population may impede a species' recovery by reducing reproduction and recruitment into the breeding population. The death of an individual from a threatened or endangered species as a result of a collision may constitute "take" as defined by the federal Endangered Species Act (1973; 16 U.S.C. 1531–1544.) and the federal Migratory Bird Treaty Act (1918; 16 U.S.C. 703–712). Companies and/or individuals may be prosecuted when powerline collisions occur, particularly if recommendations intended to reduce the risk of collision, provided by the United States Fish and Wildlife Service (USFWS) regarding the placement of the powerlines

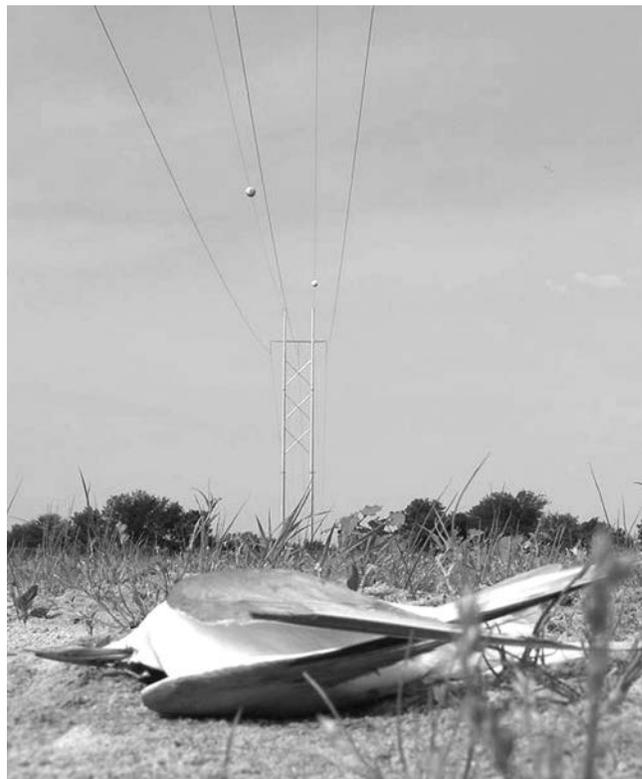
On 7 June 2012, we recovered a dead male adult interior least tern on a lower Platte River sandbar in Saunders County, Nebraska. We found the tern lying on the sand directly below a set of transmission lines mounted on tall steel H-frame structures; the set included five individual lines. The transmission lines crossed the river and a large midstream sandbar (Fig. 1). We discovered the tern's carcass in a colony that included approximately 30 adult terns associated with 13 nests, all early in the incubation period. All five transmission lines were marked with yellow, spiral bird flight diverters (APLIC 1994). These diverters were spaced approximately 15 m apart in a staggered pattern over the entire 485 m wide river crossing. The bird flight diverters were placed on the transmission lines following the recovery of a dead black tern (*Chlidonias niger*) at the same location in 2009, out of concern that the line could present risks to the legally protected interior least tern, piping plover (*Charadrius melodus*), and

The interior least tern carcass was fresh and in relatively good condition. Immediately after collection, the Nebraska Game and Parks Commission (NGPC) sent the carcass to the United States Geological Survey (USGS) National Wildlife Health Center in Madison, Wisconsin, where a necropsy was conducted. The results from the diagnostic evaluation indicated the tern was well nourished with no puncture wounds. The necropsy showed extensive hemorrhaging into the left lung and a blood clot in the left lobe of the liver; the suspected cause of death was blunt force trauma to the left side of the body (J. L. Buckner, USGS National Wildlife Health Center, unpublished data). The results exclude possible causes of death such as emaciation, disease, or predation. Other than the transmission lines, no other vertical structures were within 150 m of where the tern carcass was found. Thus, the mortality is consistent with collision with a transmission line and all other explanations have been satisfactorily excluded.

Figure 1. Dead adult interior least tern (*Sternula antillarum athalassos*) photographed on 7 June 2012 on a lower Platte River sandbar near Ashland, Saunders County, Nebraska. Photograph by Joel G. Jorgensen.

The mortality incident summarized here indicates interior least terns are vulnerable, albeit rarely, to powerline collisions that can result in mortality. This mortality incident shows that marking powerlines that are placed in areas commonly used as a feeding, nesting, or roosting site, or dividing a habitat, with bird flight diverters or other types of line markers does not completely eliminate collision risk. The problem of bird mortality resulting from powerline collisions has become more important as the growing demand for electrical power increases and the number of kilometers of powerlines needed to distribute that power increases (APLIC 1994). This increase requires utility companies and state and federal agencies to be even more conscious of environmental factors when choosing locations for new transmission lines. Entities hoping to avoid or reduce avian collision risks should use information about habitat use when making powerline placement decisions.
